AVIATION INVESTIGATION REPORT

A04W0032

LANDING BESIDE THE RUNWAY

BOEING 737-210C C-GNWN

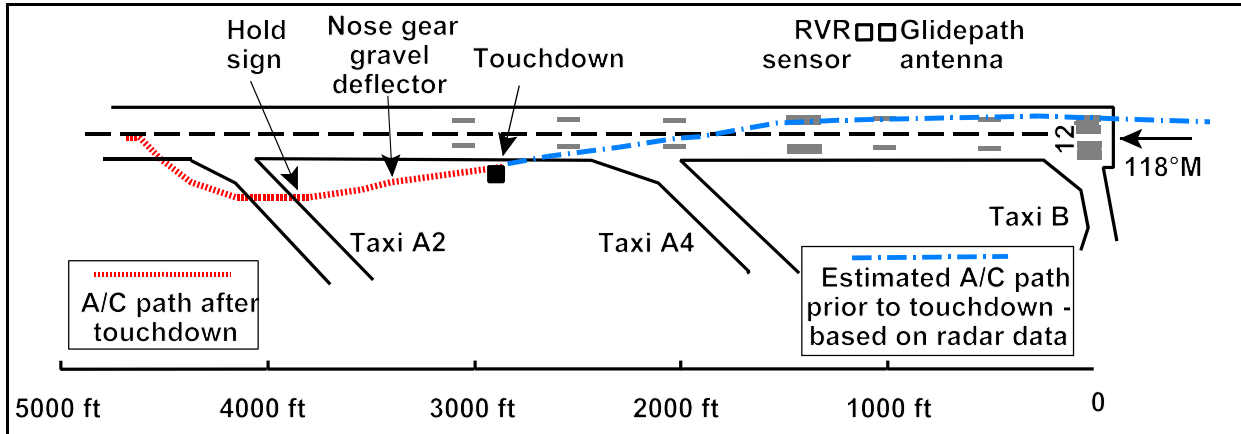
Figure 1. Overhead view of Runway 12 at CYEG

At touchdown the aircraft's heading was 117° M. The right main landing gear touched down first, approximately 8 feet off the left edge of the runway and 2700 feet from the threshold. The initial track of the main gear through the snow was approximately 109° M. Reverse thrust and a large input of right rudder were applied shortly after touchdown. The marks left by the aircraft through the snow were consistent with the aircraft sliding sideways, up to 23° nose-right of the aircraft's track. These corrective actions by the flight crew resulted in the aircraft regaining the runway after travelling 1600 feet beside it and crossing Taxiway A2. The aircraft was brought to a stop on the runway centreline, 4550 feet from the threshold (see Figure 1). At the time of touchdown, the RVR was 1200 for Runway 12 and 800 for Runway 30.

During the aircraft's rollout beside the runway, the nose gear gravel deflector detached, damaging the electrical/avionics bay doors and structure directly behind it. In addition, there were numerous areas of puncture and denting damage to the underside fuselage skin surface and a large puncture on the keel beam area of the belly just aft of the main gear. The left engine contacted and partially ingested a HOLD sign located on the west side of Taxiway A2 and both engines ingested grass and dirt.
